## **LA DURABILITÉ DE LA PRÉCONTRAINTÉ EXTÉRIEURE**

Journée Technique  
Vendredi 27 septembre 2018  
FNTP – 3 Rue de Berri, 75 008 PARIS

# HAMMERSMITH Flyover Post-Tensioning Repair Overview, the British Approach

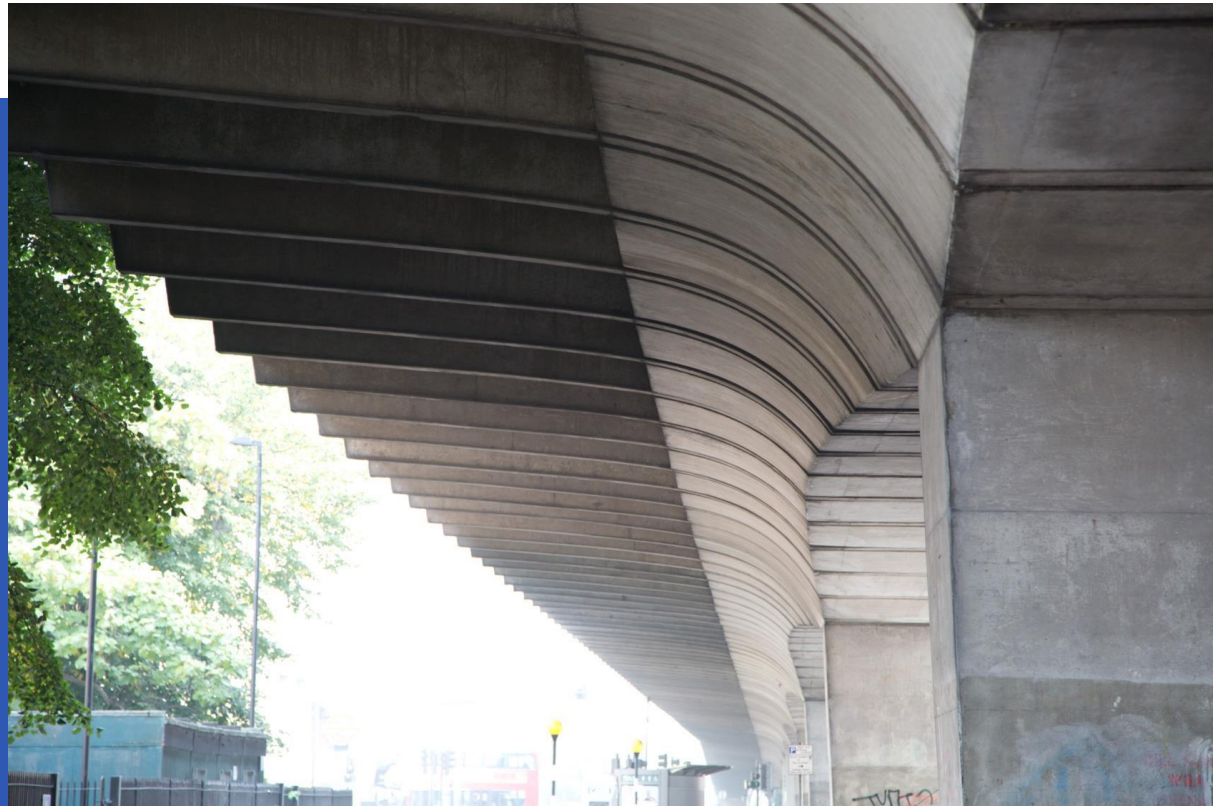
- 16 spans
- 622m elevated length
- Max box depth 2.75m
- Min box depth 1.98m
- Typical span = 42m
- 80,000 vehicles / day
- Post-tensioned pre-cast
- Bridge Owner-Transport for London (TfL)

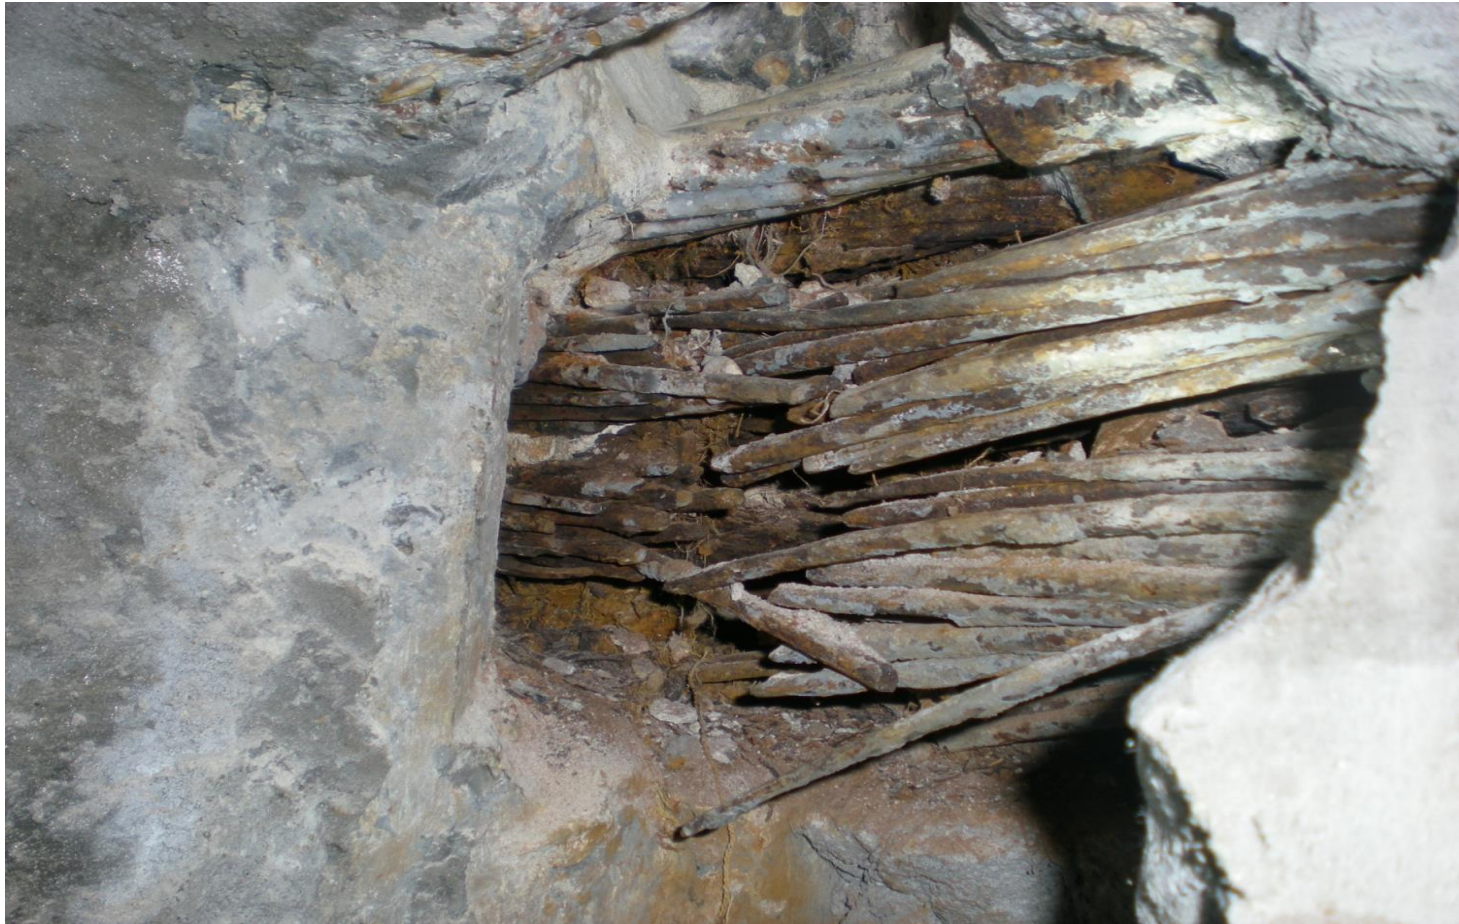
## Condition of Tendons

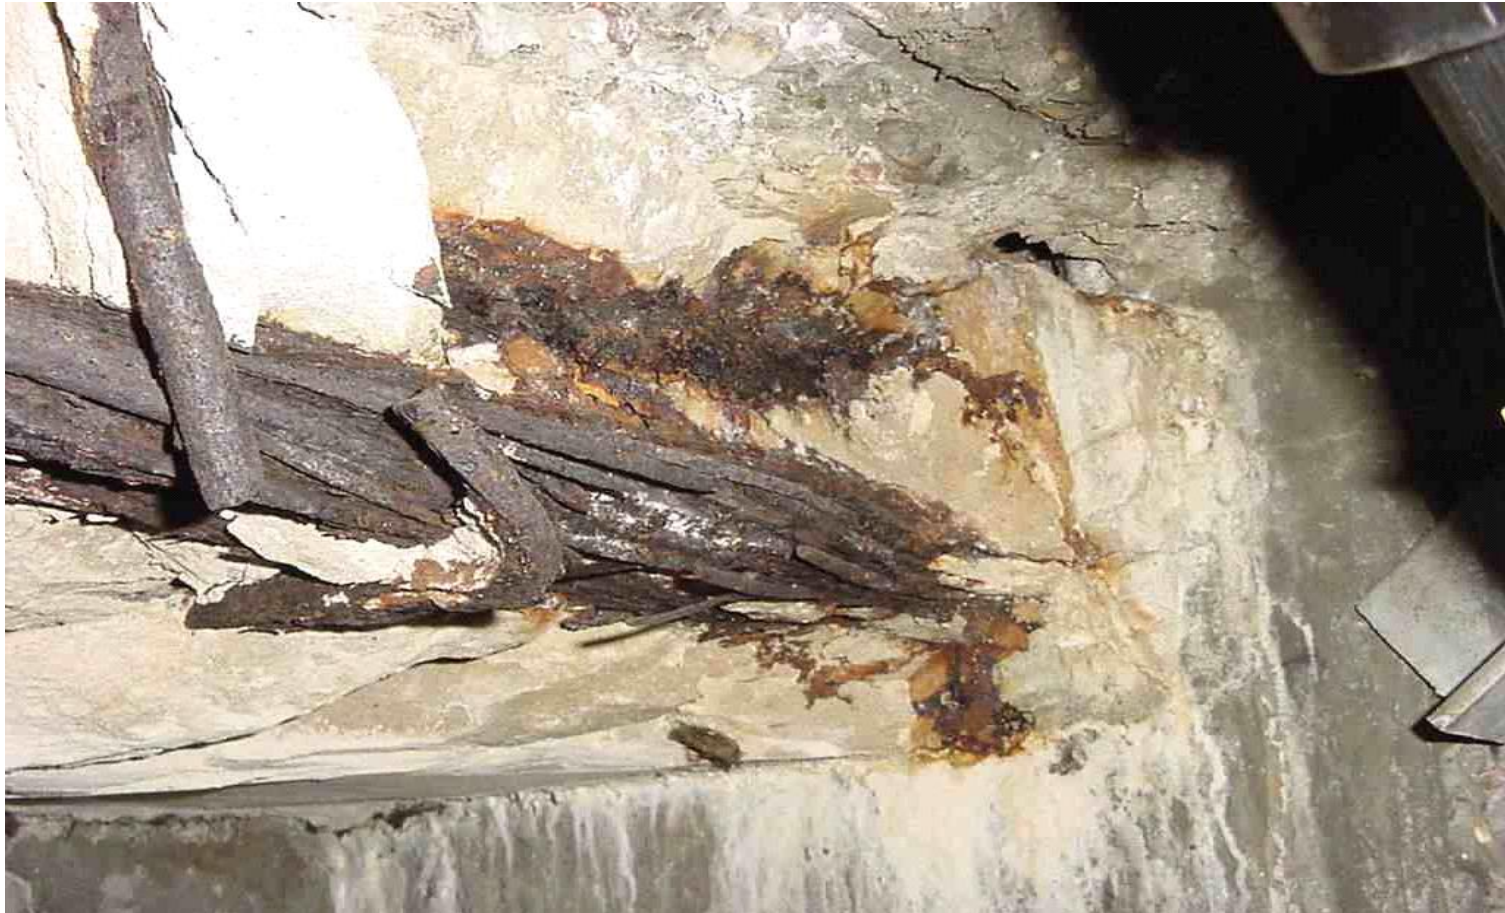
## Condition of Tendons

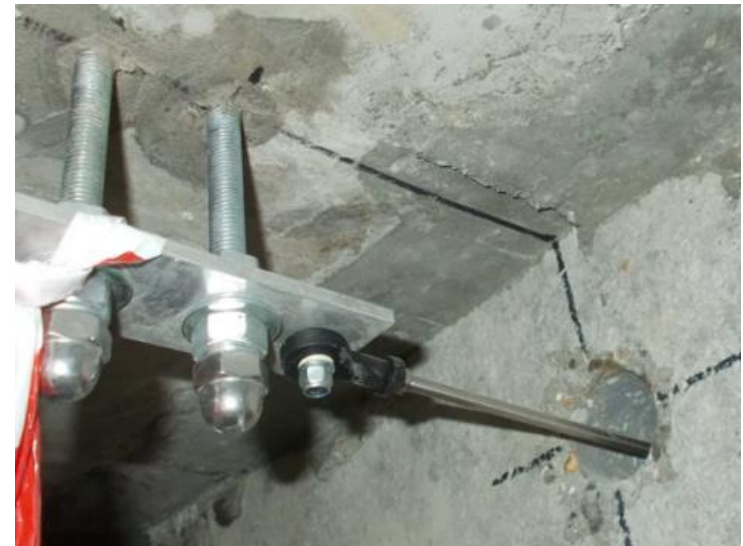
## Indirect Methods – Monitoring Strain (less accurate)

Gauges span two in-situ joints

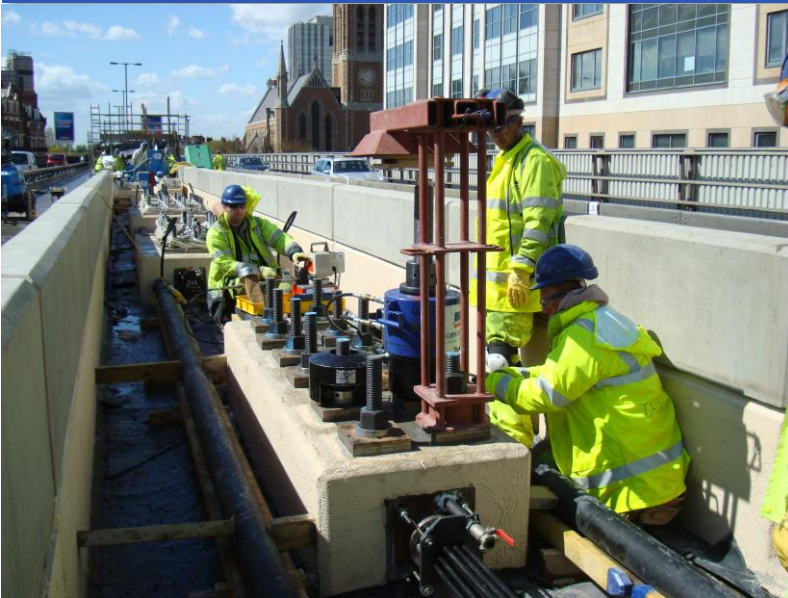
## Phase 1 Stengthening

- Emergency strengthening of the 5 worst affected piers before London Olympics.
- Ramboll not involved.
- Road closures needed.

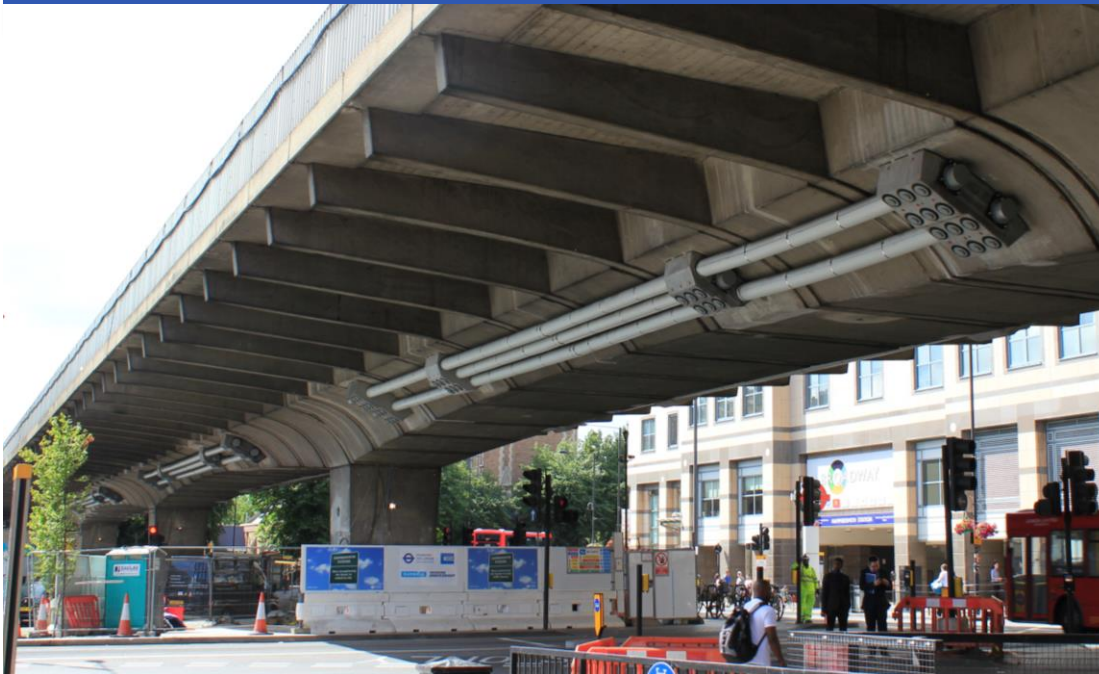
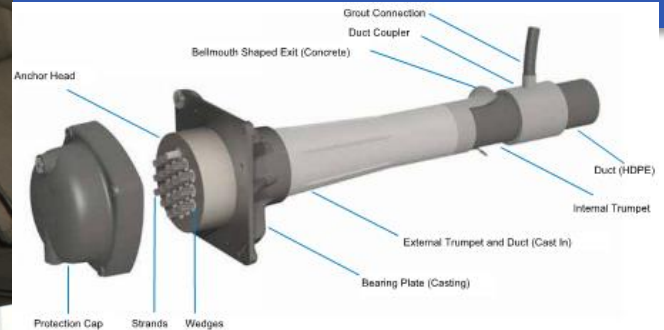
## Short Tendons – System

- PROBLEM – Cannot use grouted system.
- Grout installed before tendons stressed; temporary propping of tendon needed until tendons stressed; busy gyratory system; long term road closures not an option.
- SOLUTION – Use un-grouted, incrementally installed strands!

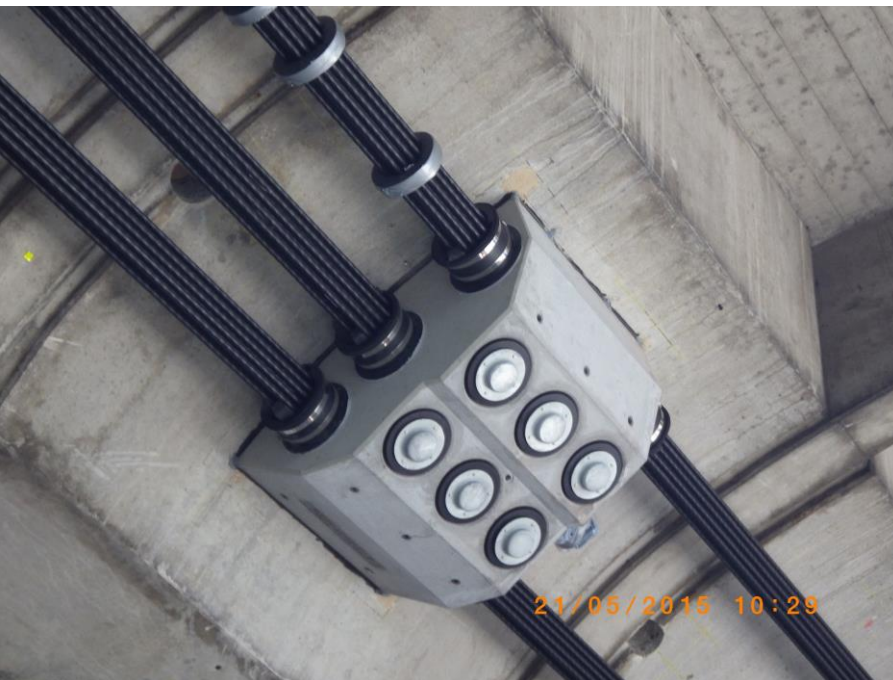
## Short Tendons – Cable Stay Technology Anchorage

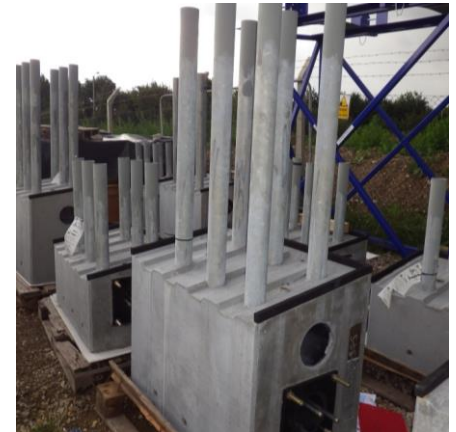
## Short Tendon – Blister Design

- Ultra High Performance Fibre Reinforced Concrete (UHPFRC) – Ductal©
- Very high compressive strength 130N/mm<sup>2</sup>; Tensile strength 10N/mm<sup>2</sup>.
- Unreinforced enabling lighter, more compact shape.
- Improved installation safety & maintained clearances.
- Avoided the reinforcement fixing tolerance and congestion experienced on Phase 1.
- Little design guidance; designed by testing.

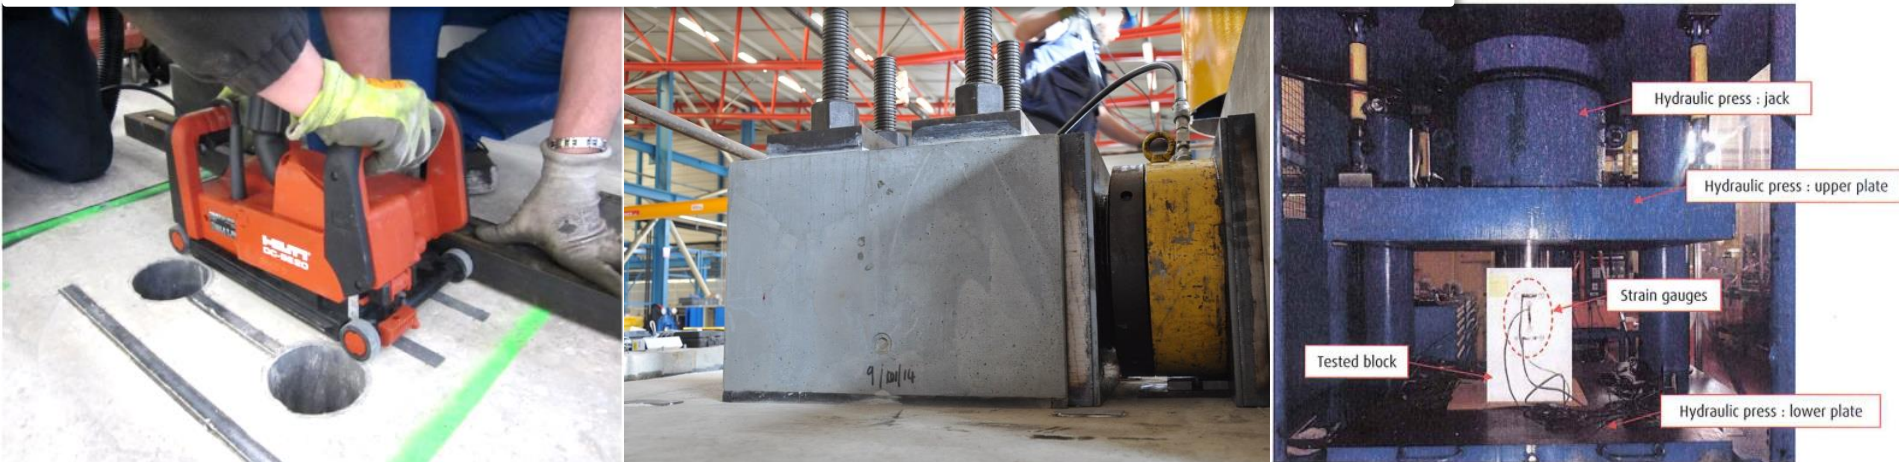
## Short Tendon – Blister Design

- Prestress anchor (bar and tendon) load transfer testing.
- Confirmation of behaviour of blister anchor zones when stressed.
- Test-bed constructed in Freyssinet factory.
- Near full scale testing of complete blister and friction interface.
- Flat jack used to replicate tendon jacking force.

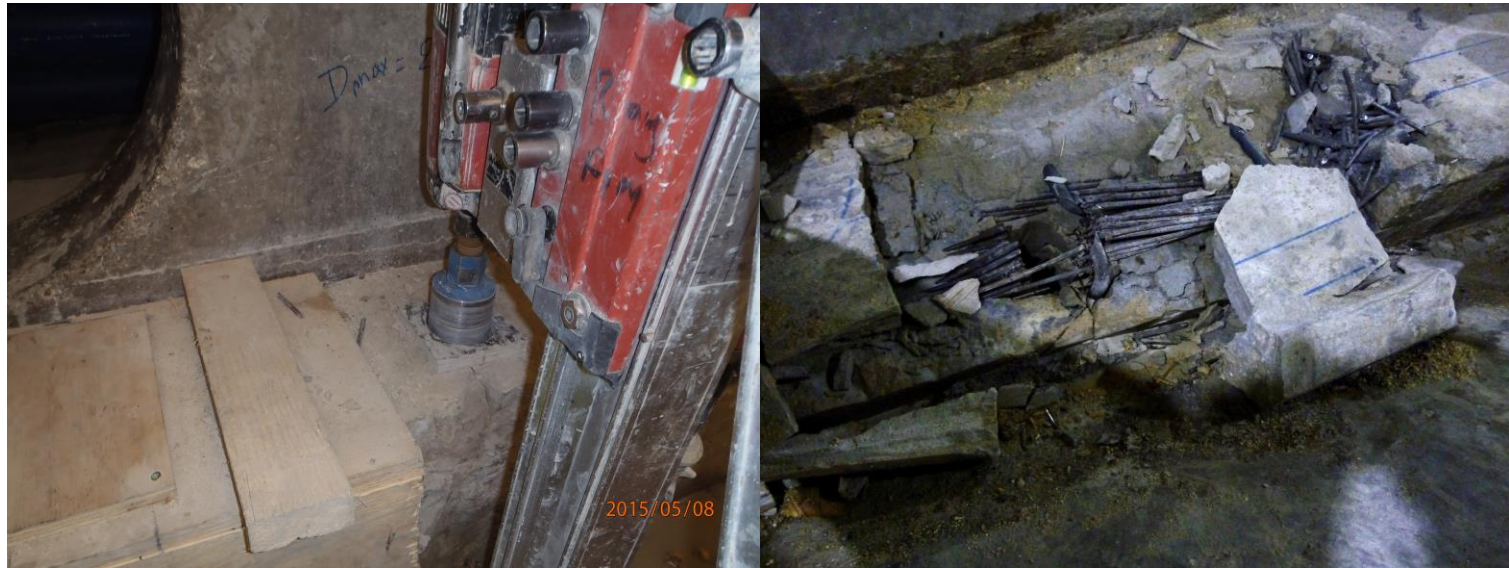
## Existing Prestress – Deactivation

- No traffic during first deactivation. Relaxed later.
- Exclusion zone plus plywood boxes to protect operatives.
- Re-anchoring was not instantaneous, the wires crept back in the concrete for several hours.
